# HELSINGIN PELASTUSLIITTO RY

## CIVIL DEFENCE SHELTER COMMISSIONING EXPERIMENT

28.9.2007 Castreninkatu 14 Helsinki

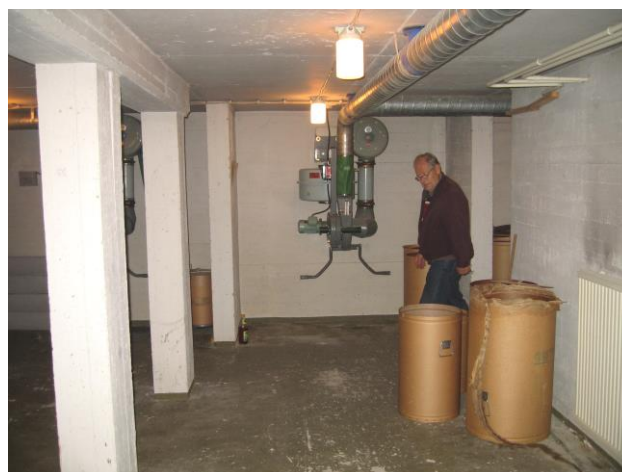
Water containers made from cardboard easily disintegrate when damp.

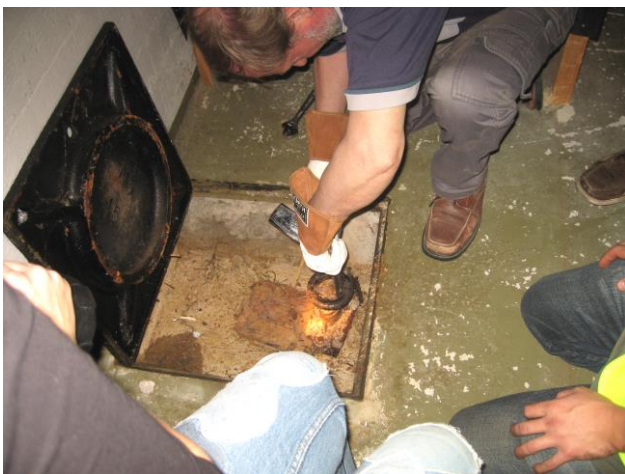
23. **Sewer shutoff valve**, which was located in the storage closet of one of the residents, could not be found during the inspection. The condition of the shutoff valve could be inspected after the shelter was cleared out. There was no movement in the valve.

Attempting to open the sewer shutoff valve.

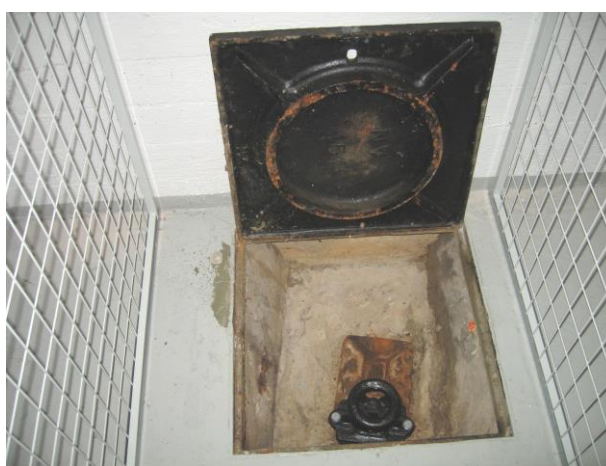
Repaired and serviced sewer shutoff valve.

**The sewer shutoff valve** was completely stuck. By help of an anti-corrosive agent, it was possible to open the valve cover. Anti-corrosive agent (CRC) was sprayed on the valve cover fixing bolts and left to work for two days. The valve cover was then relatively easy to open. The valve spindle could not be moved. Anti-corrosive agent was sprayed on the valve spindle,

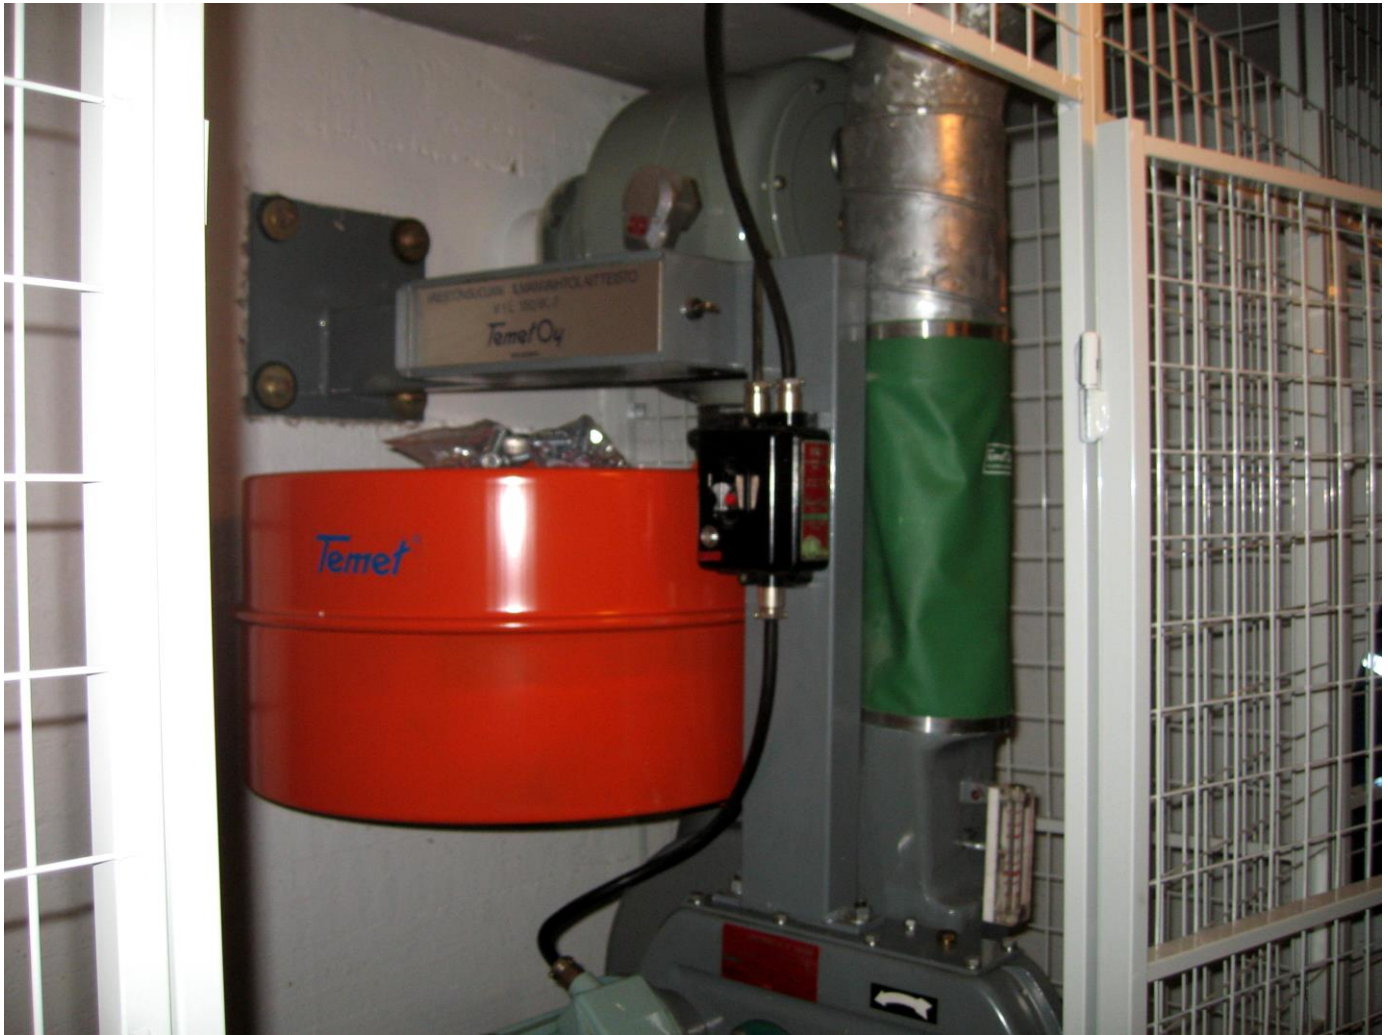
The reconditioned filter.

**Ventilation system filters.** Even if only one of the two ventilation system special filters were used during the experiment, a decision was made to replace both to ensure that they will work in the future. The operating condition of the filters and ageing of materials were examined by VTT Technical Research Centre Finland and the Finnish Defence Forces Technical Research Centre. At the time of the sheltering experiment, the filters were fully functional, but the filter that was used had taken in less than one kilogram of humidity. As humidity rapidly undermines the filtering properties of active carbon, replacing the filter was justified. The filter testing reports of both VTT Technical Research Centre Finland and the Defence Forces Technical Research Centre are attached.

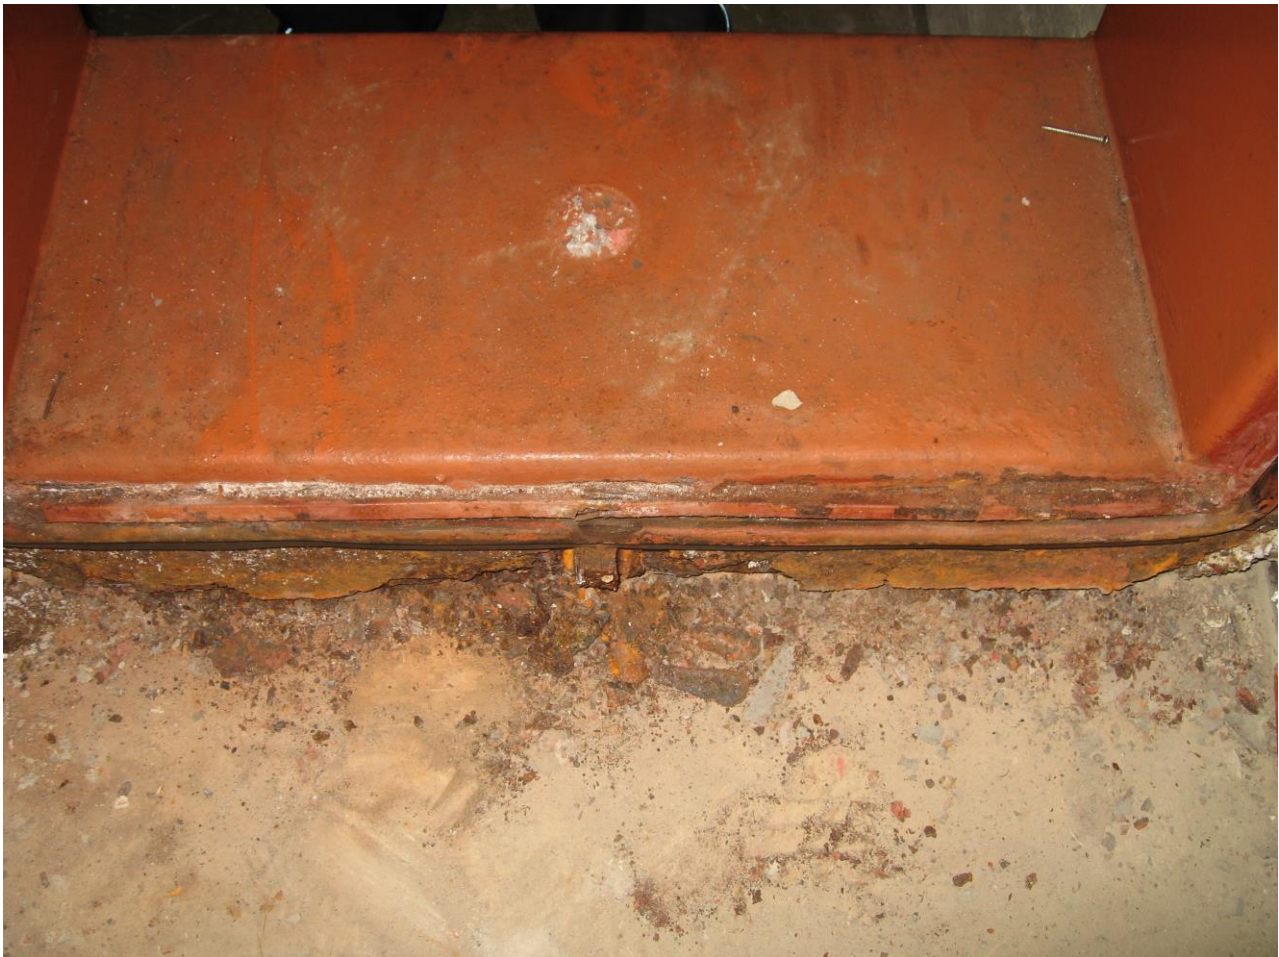
18. **Emergency exit cover hatch** (SL-1 Temet Oy) lower edge was rusty. The seal had to be replaced and the cover cleaned and painted. The positioning inspection of the cover and frame casting mould had not been carried out carefully enough, and the door leaf had either been left open or removed for casting. This is why the cover frame had remained in a distorted position compared to the cover leaf, and the

The bottom edge of the hatch was rusty and the seal was broken.

The door and the emergency exit hatch were repaired.

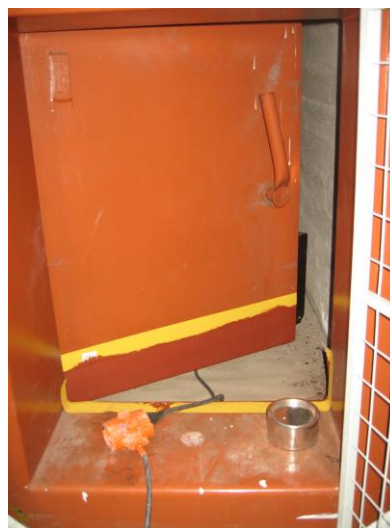
The repaired hatch.
