# HELSINGIN PELASTUSLIITTO RY

## CIVIL DEFENCE SHELTER COMMISSIONING EXPERIMENT

28.9.2007 Castreninkatu 14 Helsinki

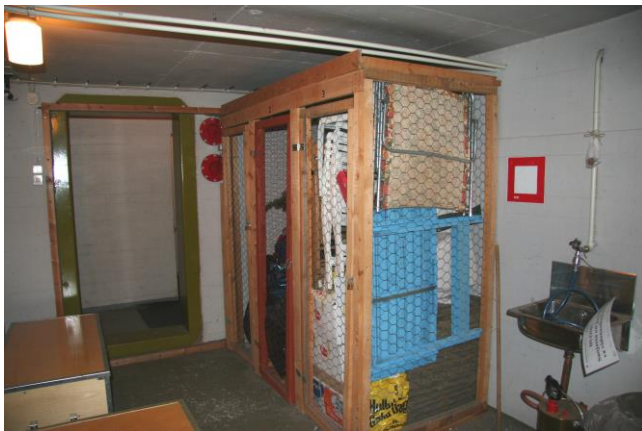
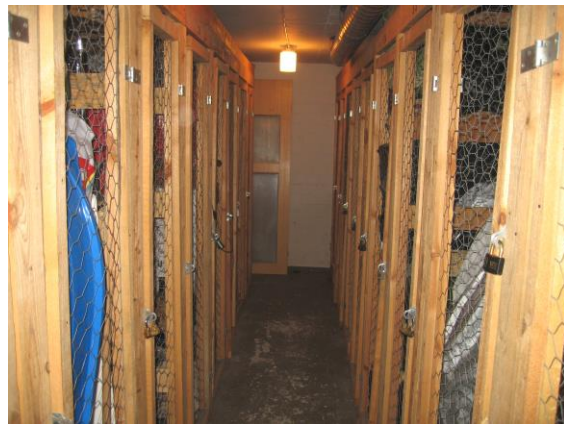
The civil defence shelter contains the private storage closets of 42 flats (so-called wire mesh cabinets) and two closets with ventilation equipment. The storage closets were built from timber and iron wire mesh. The closet size was 730 x 990 mm= 0.72 m<sup>2</sup> and used capacity 50% (0.8 m<sup>3</sup>). Four of the private closets were empty. The closets were locked with normal padlocks. The door hinges were installed so that they could be detached from the outside using a battery-operated screwdriver.

Basement storage closets

The wooden wire mesh closets were replaced by modern steel mesh closets.

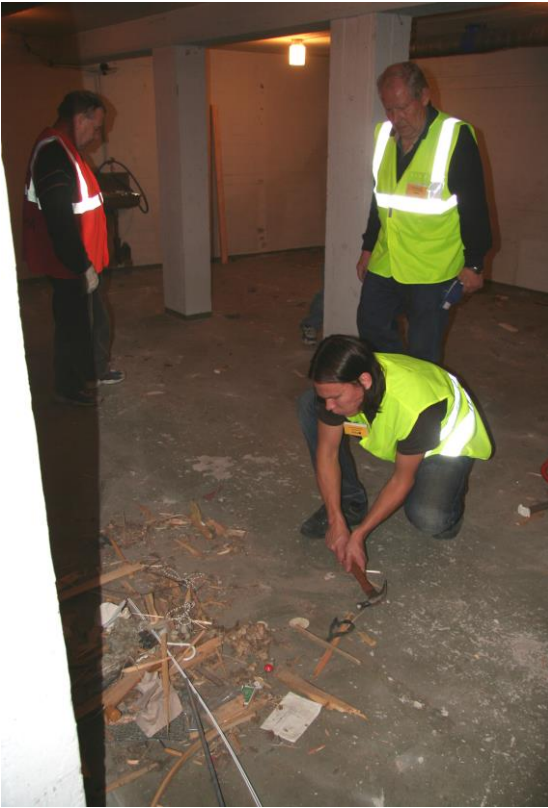
*At 9 p.m.* the clearing of the floor started. Firstly, the fixing nails of the closet bottom runners were detached or broken. These had been attached to the concrete floor by a nail gun in the construction phase, and could not be removed except by breaking with a hammer. The floor was brushed clean, which resulted in a great deal of dust.

Removing steel nails from the floor.

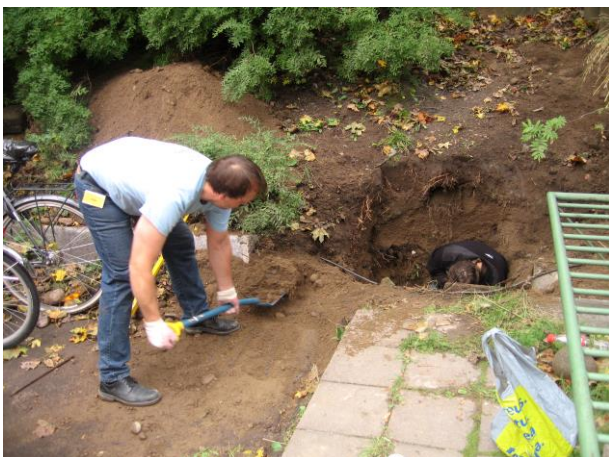
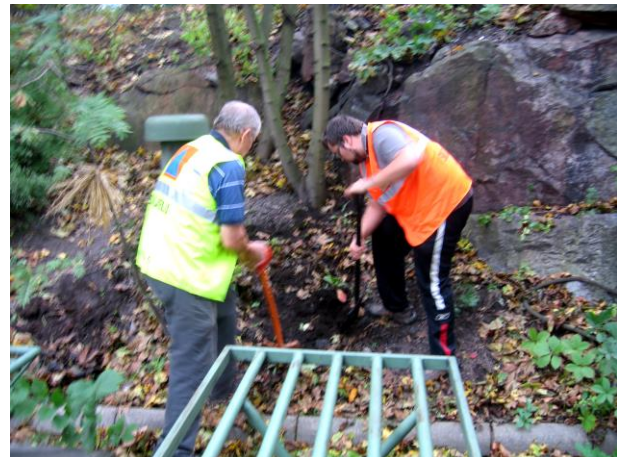
Digging out the emergency exit passage hatch.

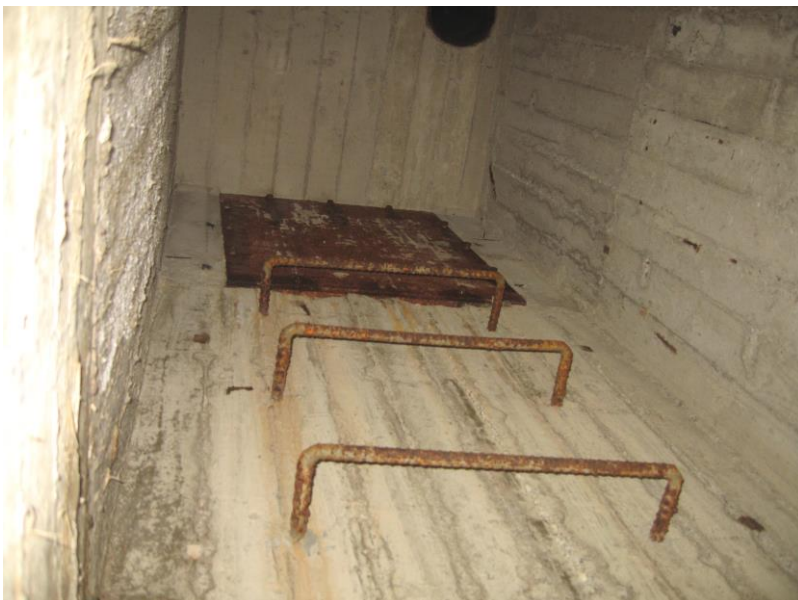
*At 12.20 p.m.* two persons attempted to open the external hatch of the emergency exit passage. The screws were completely rusted, and an anti-corrosive agent had to be applied. All but one of the screws opened. The hatch weighs 23 kg, and the team was wondering whether it was worth lifting the cover off. They decided to leave it.

Vertical shaft (5 m climb) and the cover whose bolts need to be detached.

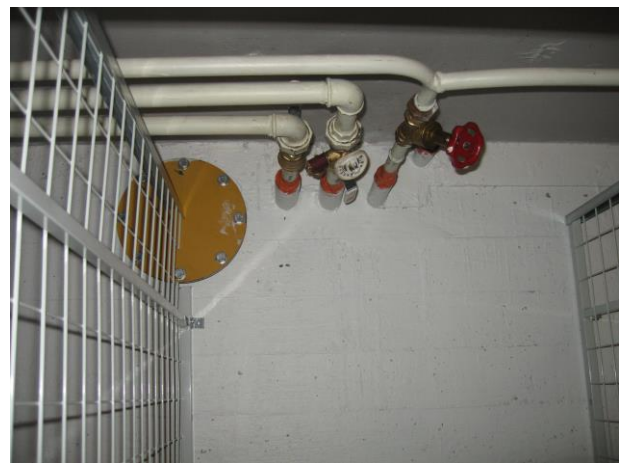
Sealing the lead-throughs with tape.

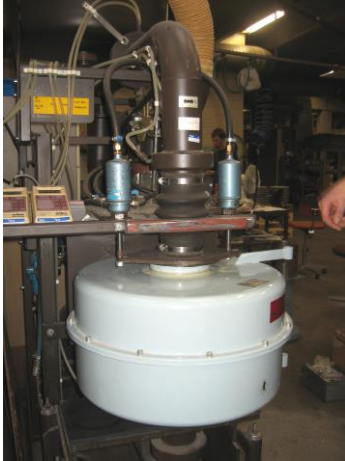
Testing the filter.

**Ventilation system filters.** Even if only one of the two ventilation system special filters were used during the experiment, a decision was made to replace both to ensure that they will work in the future. The operating condition of the filters and ageing of materials were examined by VTT Technical Research Centre Finland and the Finnish Defence Forces Technical Research Centre. At the time of the sheltering experiment, the filters were fully functional, but the filter that was used had taken in less than one kilogram of humidity. As humidity rapidly undermines the filtering properties of active carbon, replacing the filter was justified. The filter testing reports of both VTT Technical Research Centre Finland and the Defence Forces Technical Research Centre are attached.

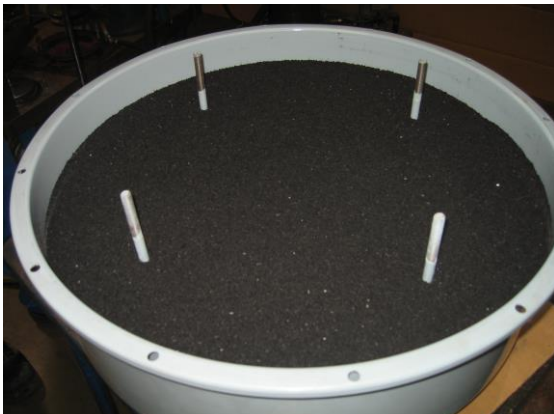
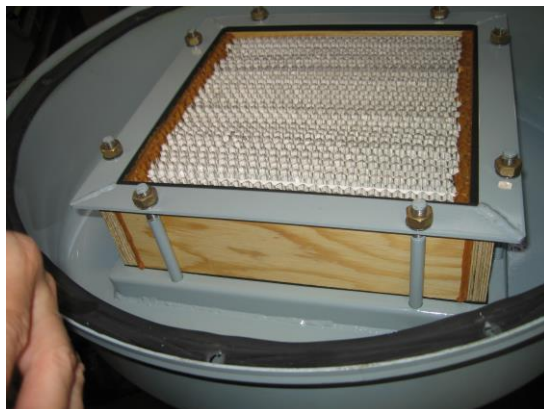
The bottom part of the filter contains carbon, while the top part contains a particle filter.

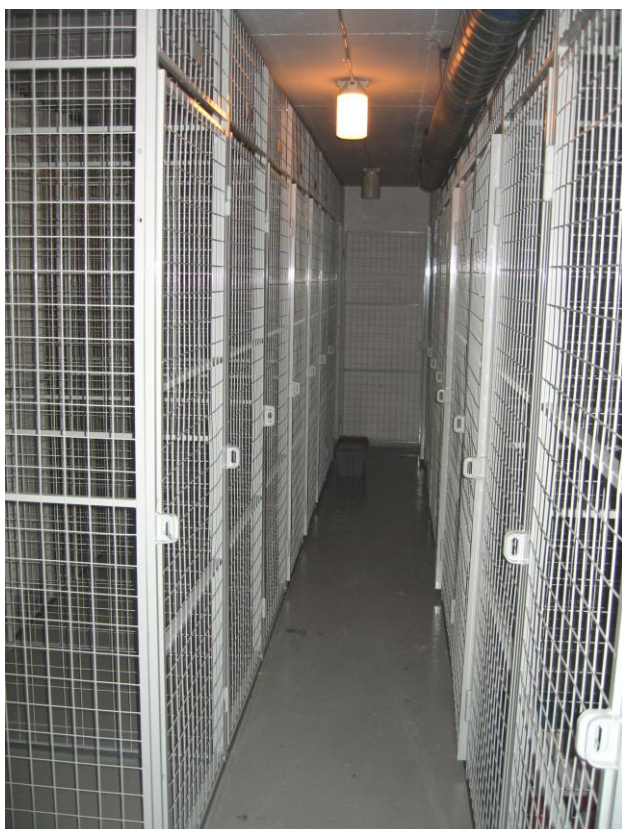
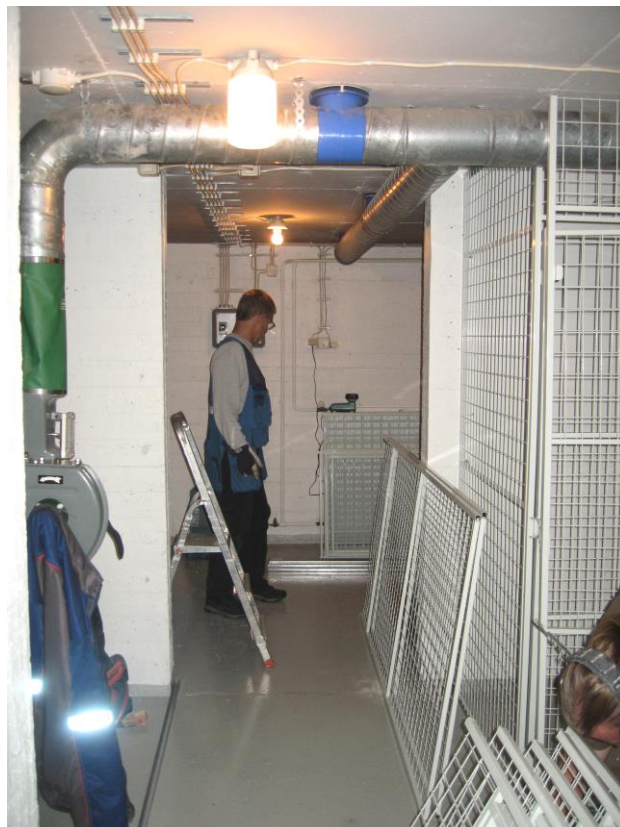
The new closets with wire mesh doors.

The old timber closets were dismantled and taken to the dump as the shelter was commissioned. For rebuilding the closets, three alternatives were examined.

1. Building closed-in closets with timber alone. This plan was abandoned because of the high fire load.
2. Closed-in closets made from profiled sheet metal. The price of this alternative was excessively high.
3. The frame and walls of the closets would be made from pure steel using standard elements. A decision was made to procure this alternative for the civil defence shelter. It took three days to build the closets.

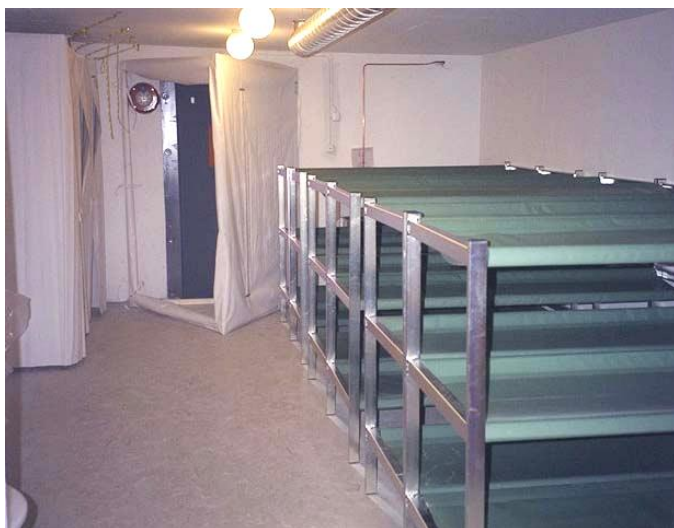
Triple bunks purchased for the civil defence shelter.

8 units of triple bunk beds were procured for the civil defence shelter, providing beds for 24, or one third of the residents.
